WorldSID 50th Pelvis Screw and Washer

W50-42013

Service Bulletin

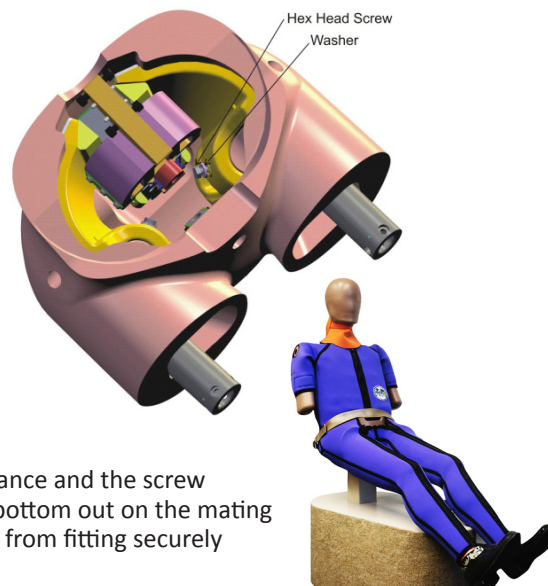
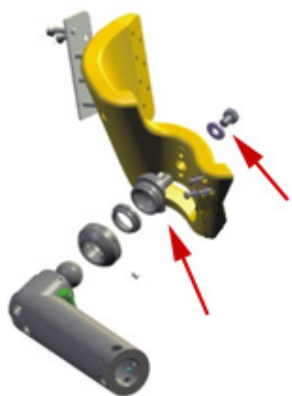
Figure 1

Under certain conditions, the M8 hex head bolt that fastens the pelvic bone to the hip joint socket may not tighten correctly, creating a loose fit (Figure 1). This can occur when the thickness of the pelvic bone is on the low end of the tolerance and the screw length is on the high side of its tolerance, causing the bolt to bottom out on the mating post of the hip joint socket and thereby preventing the socket from fitting securely against the bone.

Customers are encouraged to check their dummies for loose leg fit, and if it exists, to replace their existing screws and washers with the new screw assembly. To check for a loose fit, observe the socket bolt head against the bone while moving the femur or leg assembly. The screw or socket may move if the end of the socket post or the bolt head sits above the bone surface after being tightened down. Affected components are listed below.

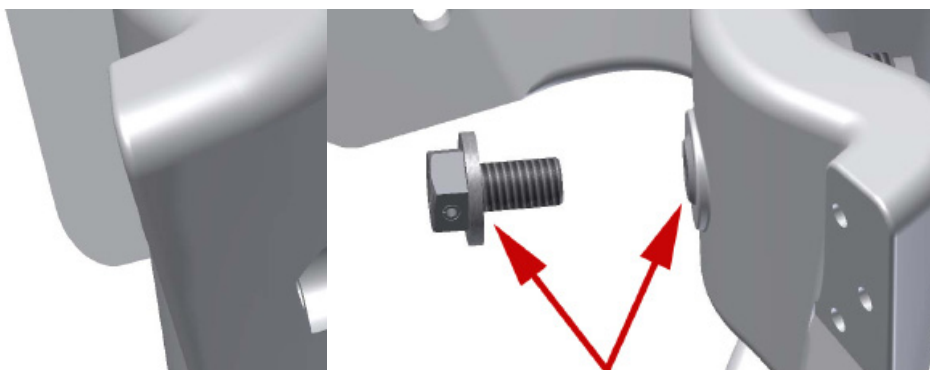
Figure 3

To provide a solution for existing dummies in the field that exhibit a loose leg fit, a new bolt and washer assembly has been created that allows the bolt to tighten properly on the hip socket component, thereby creating a secure fit against the bone. The thread length is modified and the washer component has a recessed channel which allows the lip of the pelvic bone hole to seat within it (Figures 2 & 3).
