WSID 50th New Clevis & Arm

W50-63112, W50-63111, W50-63100

Publication Date: March 2016

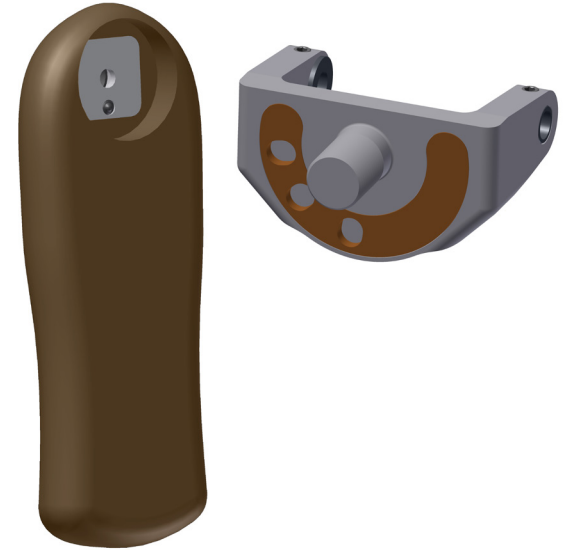
Users of the current WorldSID 50th ATD have noted that arm positioning can be difficult because it can be hard to feel the intermittent click stops that set the arm into one of several positions. In addition, the arm would sometimes move from suit tension after setup.

Under the direction of the Task Group, Humanetics beefed up the design of the clevis, using larger plunger ball holes that seat the arm into position. The number of holes was decreased and limited to three per side to eliminate possible handling issues such as mounting the clevis upside down, and positioning the arms incorrectly during certification testing. These new click stops improve the set-up performance as the arm position is better defined. This redesign also necessitated the creation of a right and left side clevis, thus making the current universal component obsolete.

The plunger ball in the arm was also made more robust by increasing its size to match the new

clevis click stops.

The new clevis and arm will be worked into normal ATD production, but will also be sold individually for those interested in updating their dummies. Old arms are not compatible with the new clevis design and must be replaced with the new arm to assemble correctly.
